The Mars Rover Spirit FLASH Anomaly

Glenn Reeves
Tracy Neilson
Jet Propulsion Laboratory (JPL)
Pasadena, CA 91109
818-393-1051

Abstract—The Mars Exploration Rover “Spirit” suffered a debilitating anomaly that prevented communication with Earth for several anxious days. With the eyes of the world upon us, the anomaly team used each scrap of information, our knowledge of the system, and sheer determination to analyze and fix the problem, then return the vehicle to normal operation. This paper will discuss the Spirit FLASH anomaly, including the drama of the investigation, the root cause and the lessons learned from the experience.¹

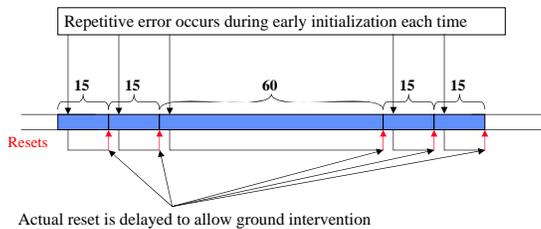
Figure 1: Delayed reset behavior

When the FSW detects a severe error, it reacts by forcing a reset of the flight computer and a re-initialization of the FSW. If the FSW determines that a reset is necessary during the FSW initialization process, the FSW delays the actual reset until a minimum time period has passed. This process is referred to as a "delayed reset". The intent is to allow sufficient time for ground intervention.

When the delayed reset time expires, the reset is initiated. The system keeps track of the number of repetitive resets and modifies the delayed reset time interval. The boot logic part of the software also keeps track of the number of initialization attempts and is designed to load and start alternating copies of the FSW with each reset. By design, the time period between resets is set to a fifteen minute delay for the first severe error, fifteen minutes for the second, and then one hour for the third. This pattern then repeats (see Figure 1). Commands can be processed and communication windows can occur during the delayed reset period.

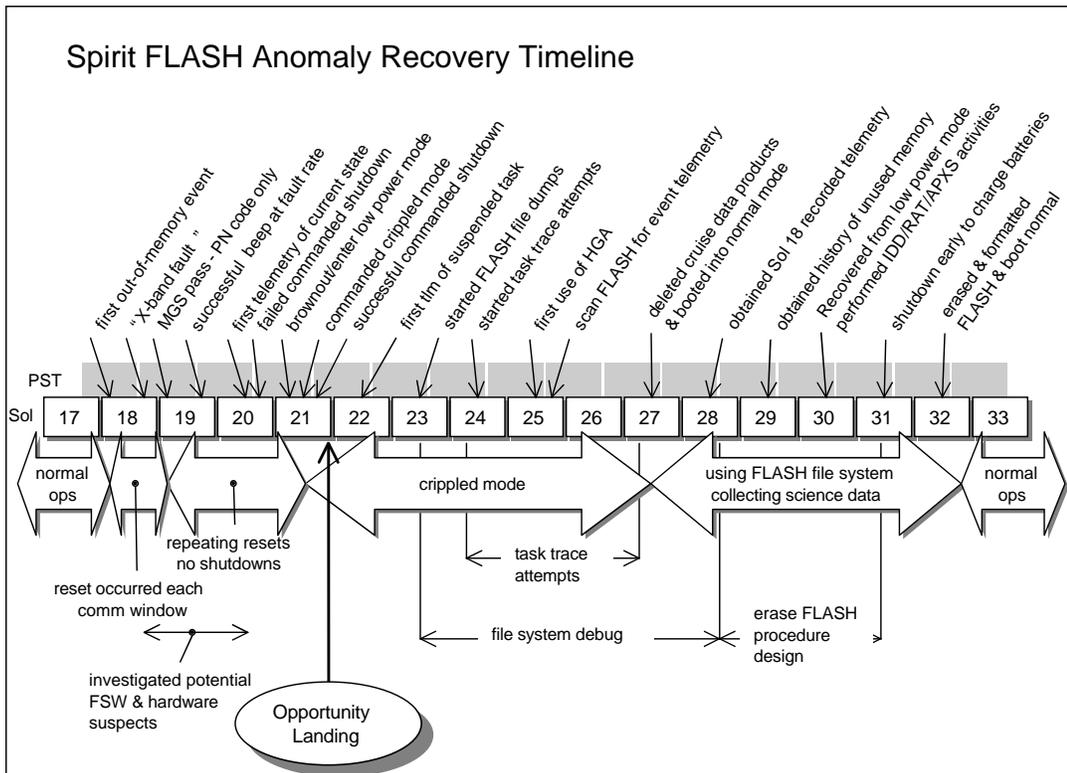
Figure 2: Anomaly events and recovery timeline

For the next 11 sols, we attempted to diagnose the precise cause of the problem, recover science and engineering data still in the FLASH memory, and return the vehicle to a science-taking machine. During this time, the press started to refer to us as us "space-age surgeons". The timeline of the anomaly investigation and recovery is shown in Figure 2.

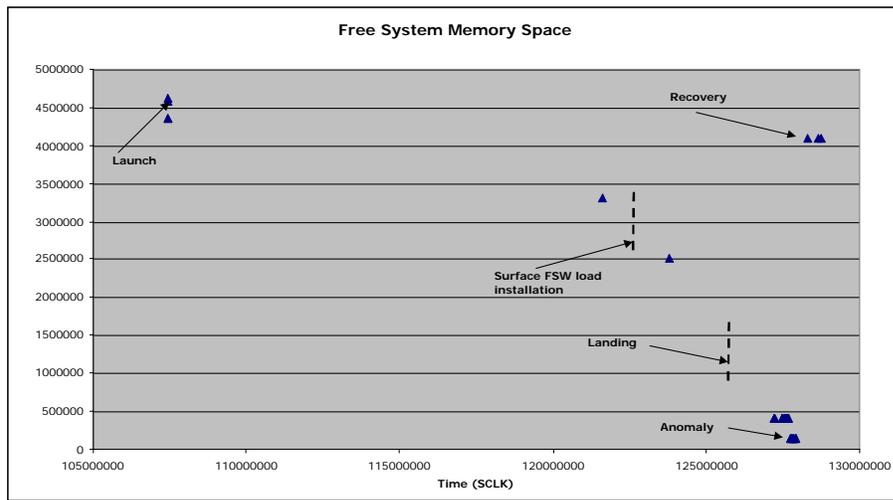
Figure 3: Flight telemetry of Spirit's free memory space

Figure 3 shows Spirit's in-flight telemetry of the free memory space from launch through recovery. Note we did not connect the segments on the figure because that would be misleading regarding the rate of decrease in the system memory space. Insufficient data exists to extrapolate when each request for new space occurred. This data was not examined until the anomaly occurred.

Lesson: The FSW should have included flight telemetry for resources (such as the free system memory space) so that the actual and expected behavior of the system can be compared.
